Project for the Preservation and Promotion of Kuwait's Cultural Heritage

MUSEUM OF MODERN ART STORAGES

Survey Report

March 2018

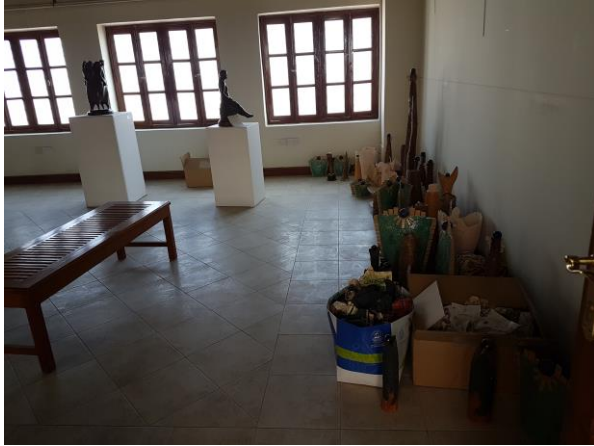
The museum collection consists of paintings, ceramic objects and sculpture (Fig. 1, 2). There is no digital registration of objects.

Fig. 1: Ceramic objects and sculpture

It was observed that the objects of the collection were generally in good condition. Main aggressors are environmental instability, incoming natural light, lack of environmental monitoring, dust and inadequate physical support of the objects. Almost all objects are placed on the floor with the exception of sculptures on pedestals.

Storage units should be **adapted** to the dimensions and type of the objects store. This will both improve the protection of the collection and the efficient use of the space. Custom made equipment is available to store 2D objects. Larger objects should be stored in the lower shelves or on storage platforms, pallets or carts on wheels. No object should be directly placed on the floor.

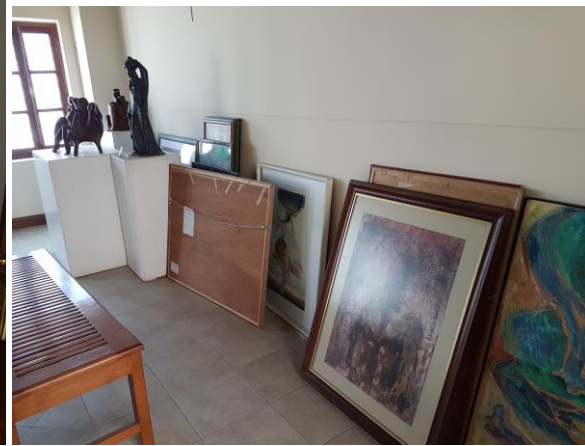
Fig. 2: Paintings and sculpture

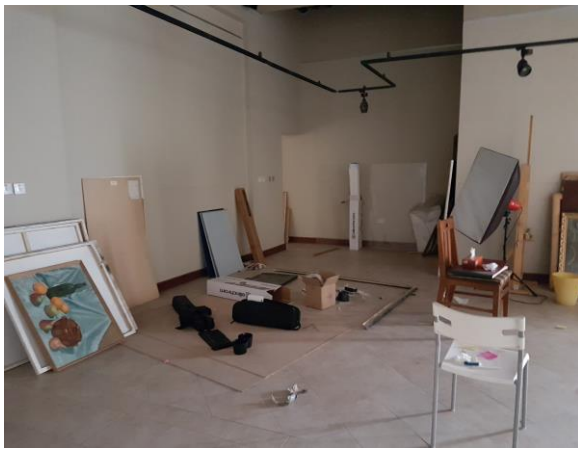
- The Director is currently on the process of photography and scanning 2D objects (Fig. 3).
- The way the storage is organised cannot be used (Fig. 4).
- Having a logbook to record visitor's use and object movement will provide useful data for the museum storage use.

Fig. 3. Photography of paintings

Activities as study, photography and registration of objects should be undertaken in separate, specific rooms connected to the storage areas.

- The Museum should allocate areas for supplementary activities connected to storage management

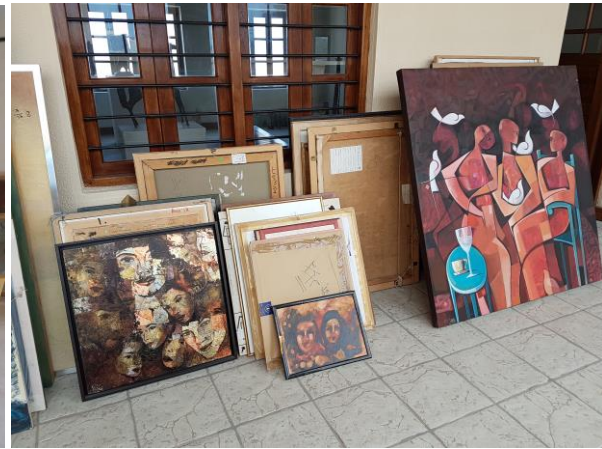
Cleaning of the storage area is not efficient, as many objects are directly placed on the floor. The storage is in need of organised, regular housekeeping.

Fig. 4. Paintings on the floor

The Storage areas should be easy to clean and should be kept as dust free and clean as possible. It is therefore necessary to keep floors and aisles empty of objects. A good **housekeeping** system should be established so that storages are regularly cleaned by trained staff.

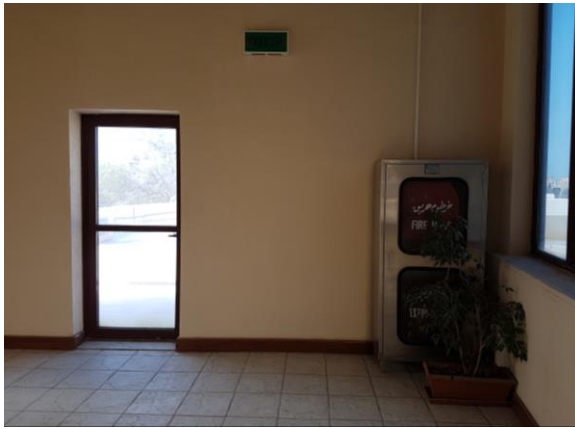
Fig. 5: Fire hose station

- The floor is equipped with a fire hose station (Fig. 5).
- There are no smoke detectors on the ceiling of the rooms.

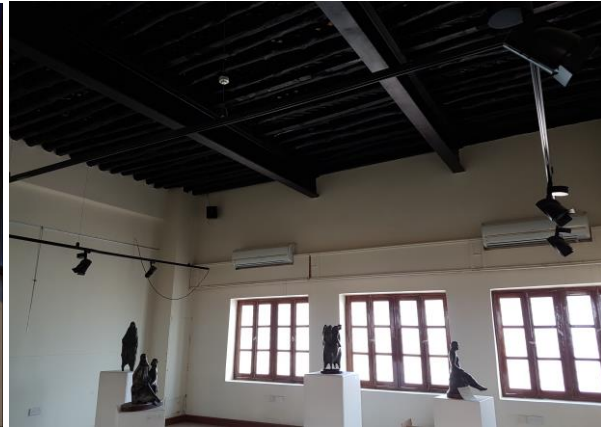
MOMA uses the first floor to store the collection. The structure itself is in good condition. The main drawback is incoming natural light through windows. All piping for air-conditioners runs on top of windows, along one side of the rooms.

- There are two air-conditioners in each room (Fig. 6)
- There are no portable humidifiers or de-humidifiers.
- There are no fans on the ceilings.
- There are no exhaust fans.
- There are no dust-filtering units.

Fig. 6: Air-conditioners and windows

Environmental monitoring and control is essential for the protection of the collection. Installation of data loggers will provide useful information on the storage environment. The use of humidifiers and dehumidifiers will provide a stable environment and can improve the preservation of sensitive material. Windows should be screened.

- MOMA should purchase and install an environmental data-logging programme. Study of the data will be used to assess the current conditions.
