COMMONWEALTH OF DOMINICA

Rapid Damage and Impact Assessment Tropical Storm Erika – August 27, 2015

A Report by the
Government of the Commonwealth of Dominica

September 25, 2015

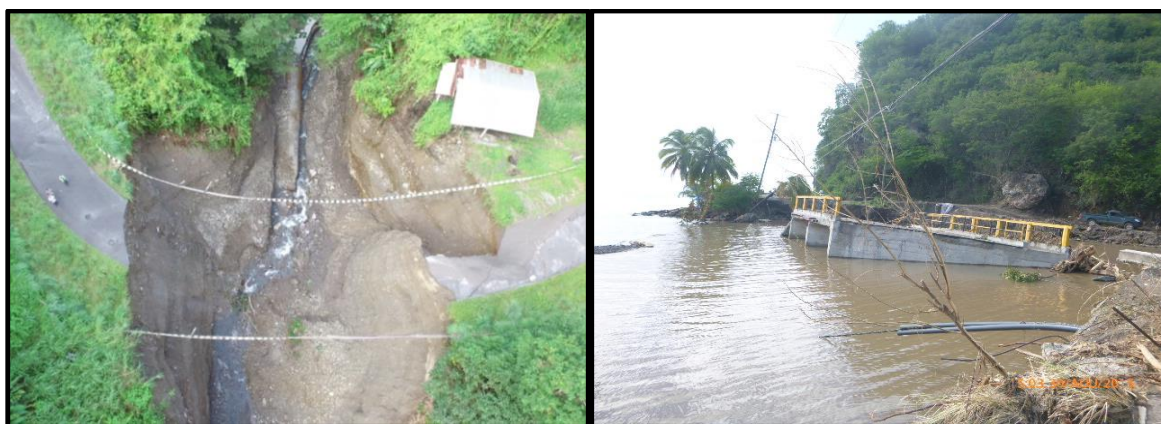
Figure 1 (a) Drone view of collapsed road at Boetica’s Gorge (depth 25m, length 50m) and (b) Batali Bridge, West Coast Road

- Undertake urgent abutment reconstruction, foundation stabilization and approach protection of partially damaged or undermined bridges
- Undertake a comprehensive and detailed landslide assessments, apply speed restriction and traffic restriction to avoid total collapse
- Clean up rivers, drainage systems and restore hydraulic capacity of bridges by removing blocks, trees or materials

- Construct low cost river crossings using pipes (e.g. in Macoucherie, Batalie, Pointe Ronde)
- Prepare construction sites and install temporary bridges at minimal cost (e.g. at Batali and Pointe Ronde)
- Rehabilitate damaged critical points

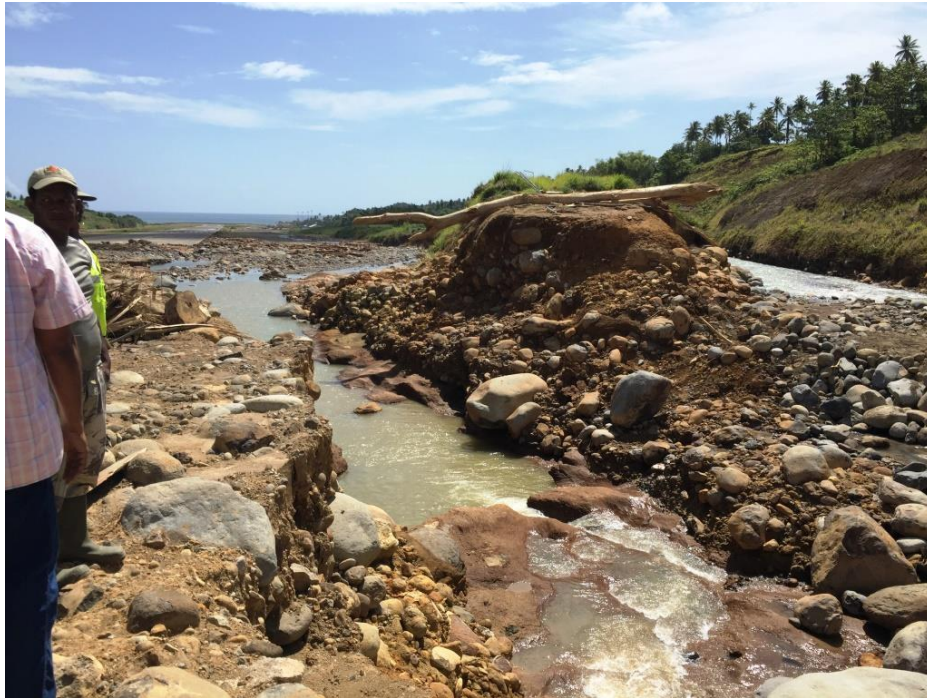
Collapse of Barrage which Caused Inundation of the Airport

Impact of Disaster. Both Canefield Airport and Douglas-Charles International Airport were flooded, however, the substantial damages occurred at Douglas-Charles due to the flooding and the accompanying mud deposits. The river by the airport most likely became clogged by debris further upstream, and as this temporary natural dam gave way, the currents became powerful enough to break the dam at the western end of the airport. The airport was powered at the time, resulting in loss of all electrical equipment that came into contact with the water. The flooding was followed by an extensive deposit of mud and debris, which penetrated all buildings and fixtures on their ground floors (see Figure 2 and Figure).

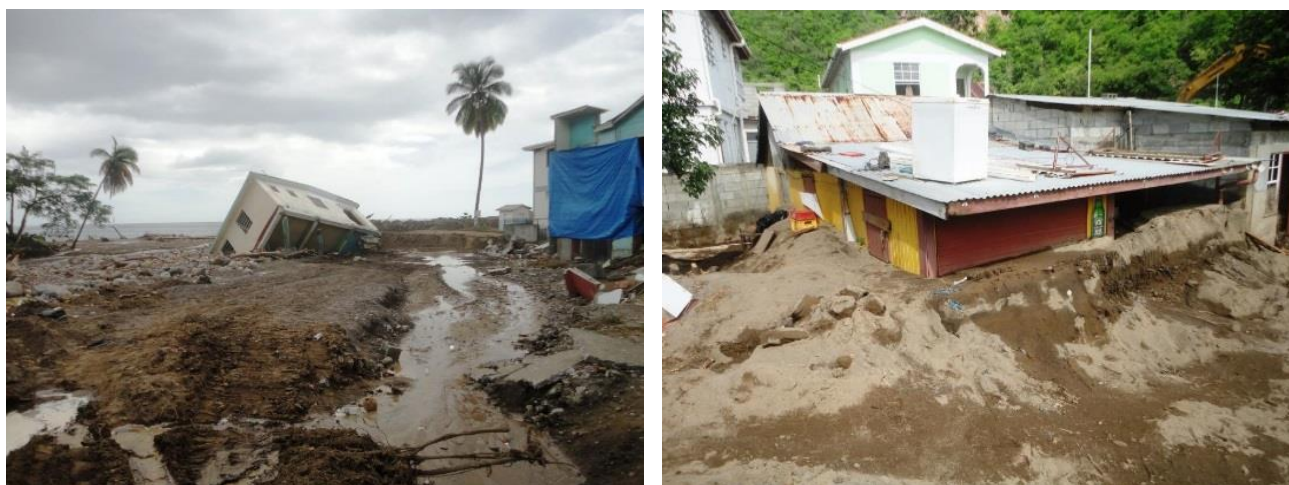
Houses in Colihaut (Credits: International Organizations for Migrations)
